New Port - Tampa Bay
Community Development District

Review of Risk Services Site Visit Report

RISK SERVICES
SITE VISIT REPORT

New Port Tampa Bay Community Development District

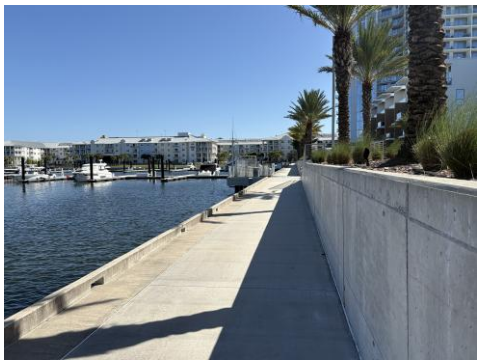
1. Attractive Nuisance

While the District has taken proactive steps by issuing formal notice to remove the dock, the current measures in place to restrict access and prevent use do not provide a sufficiently robust means of control.

To reduce the potential for unauthorized access and associated safety and liability concerns, it is recommended that fencing be installed at the entrance to the gangway to effectively block access to the dock. Adequate signage should also be posted indicating that the dock is closed and not authorized for use.

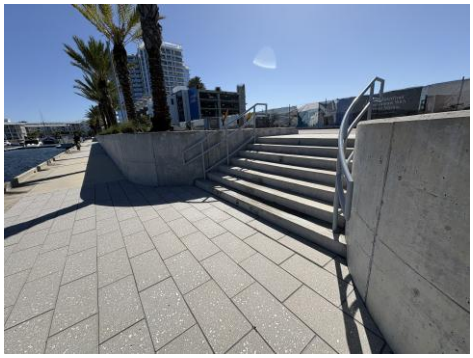
3. Trip & Fall

During the site visit, a section of metal from a previously removed signpost was observed protruding from the walking surface.

Would advise that the protruding metal remnant be removed or cut flush with the walking surface as soon as practicable to eliminate the potential trip and injury hazard. Following removal, the area should be repaired as needed to provide a smooth, even walking surface.
